**Flood Control Project Maintenance  
Levee Inspections**

**Fall 2018 Levee Maintenance Deficiency Summary Report**

**Flood Control Project Maintenance  
Levee Inspections****LMA District Cover Sheet****Fall 2018 Levee Inspection Results****Sutter Maintenance Yard East-West Interceptor**

**Sutter Maintenance Yard East-West Interceptor**

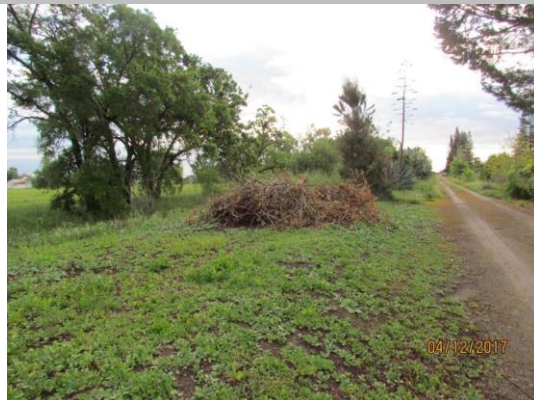
Photo 1 of 1 : FA\_2018\_ST0020\_213\_12\_20180905\_00007.jpg

View of the prunings along the waterside slope.

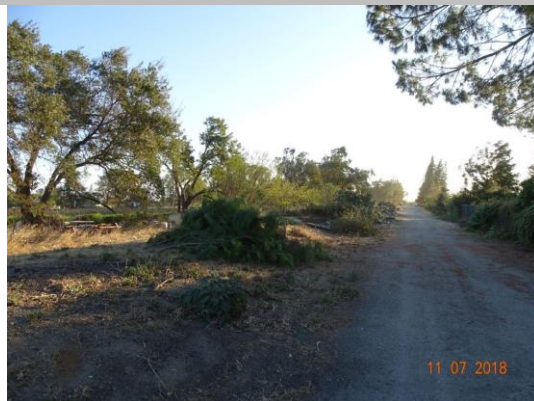
Photo 1 of 2 : FA\_2018\_ST0020\_213\_2\_20181113\_00021.jpg

LM Start	0.23	Rating **	M	Issue No.	2
LM End	0.25	Issue Type +	En	Location *	WS
Category	Earthen Levee			GPS Latitude/Longitude	
				Start	End
Item	Vegetation			39.171418 °	39.171408 °
				-121.755963 °	-121.755578 °
DWR ID	DWR_NA0020_01_s_2012_2				
Comment Code					
V6 : Landscaping					
Inspector Comment					
Remove the cactus and pine trees from the waterside berm.

View of the pushed over cactus and pine trees along the waterside berm.

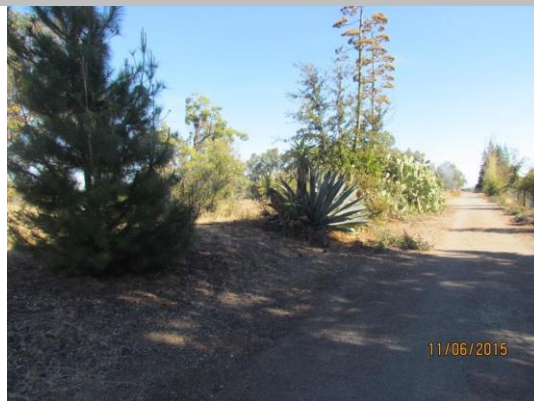
Photo 2 of 2 : FA\_2018\_ST0020\_213\_2\_20180905\_00002.jpg

LM Start	<b>0.23</b>	Rating **	M	Issue No.	<b>2 (cont)</b>
LM End	<b>0.25</b>	Issue Type +	En	Location *	WS

View of the cactus and pine trees along the waterside berm.

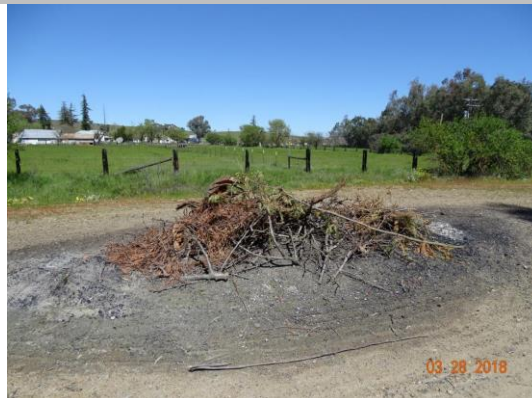
Photo 1 of 1 : FA\_2018\_ST0020\_213\_7\_20180905\_00006.jpg

View of the prunings along the crown.

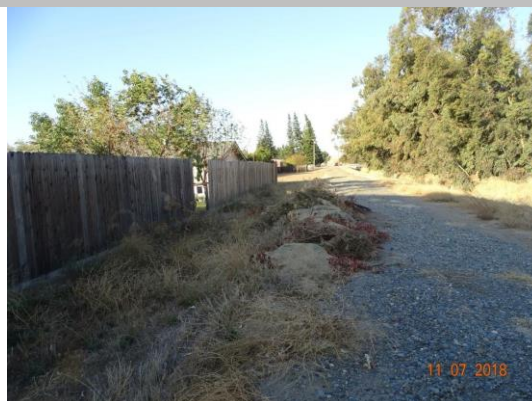
Photo 1 of 1 : FA\_2018\_ST0020\_213\_14\_20181113\_00022.jpg

LM Start	0.45	Rating **	M	Issue No.	14
LM End	0.45	Issue Type +	En	Location *	LS
Category	Earthen Levee			GPS Latitude/Longitude	
				Start	End
Item	Encroachments			39.171453 °	39.171453 °
				-121.751603 °	-121.751603 °
DWR ID	DWR_ST0020_01_f_2018_14				
Comment Code					
PR : Prunings					
Inspector Comment					
Removed the prunings from the landside crown.

View of the prunings along the landside crown.

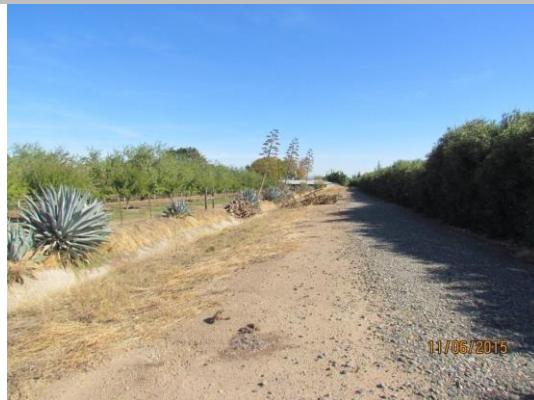
Photo 1 of 1 : FA\_2018\_ST0020\_213\_1\_20180905\_00001.jpg

View of the cactus tree that has fallen on the waterside slope.

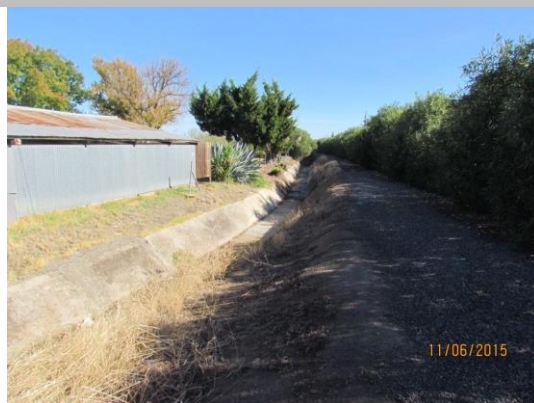
Photo 1 of 2 : FA\_2018\_ST0020\_213\_4\_20180905\_00004.jpg

LM Start	0.62	Rating **	U	Issue No.	4
LM End	0.65	Issue Type +	Ma	Location *	WS
Category	Earthen Levee			GPS Latitude/Longitude	
				Start	End
Item	Erosion / Bank Caving			39.171292 °	39.171232 °
				-121.748868 °	-121.748175 °
DWR ID	DWR_NA0020_01_s_2012_4				
Comment Code					
E2 : Schedule repair of erosion site prior to the next inspection.					
Inspector Comment					
Repair the erosion along the concrete ditch.

View the erosion along the concrete ditch.

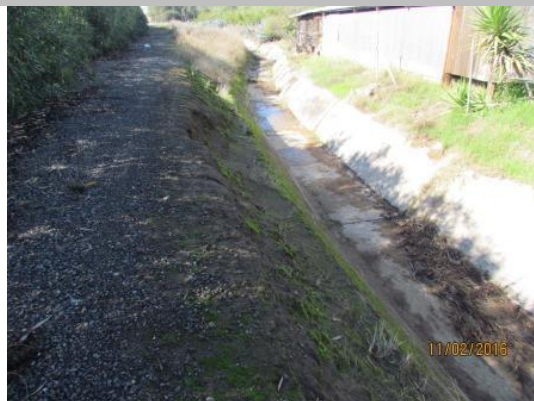
Photo 2 of 2 : FA\_2018\_ST0020\_213\_4\_20180905\_00005.jpg

LM Start	<b>0.62</b>	Rating **	U	Issue No.	<b>4 (cont)</b>
LM End	<b>0.65</b>	Issue Type +	Ma	Location *	WS

Another view the erosion along the concrete ditch.

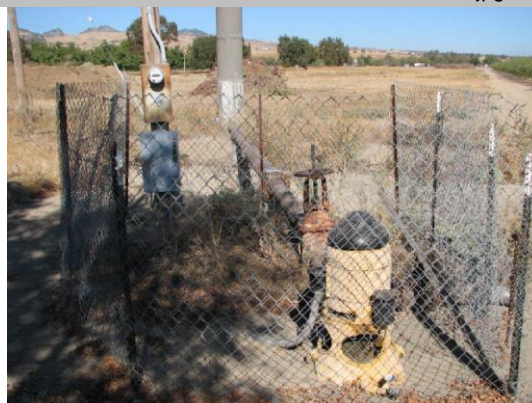
Photo 1 of 2 : UCIP\_FA\_2018\_51523\_11344.jpg

Comment Code						
Inspector Comment						
FS_ID:51523 DS_ID:19417 EP_NO: N/A Repair Type: Non-Urgent Crossing Status: Found UCIP Comments: 4/10/2017 Crossing appears to have been abandoned. (DWR Sutter Yard- A Freitag)4/19/2016 Meter has been removed from the power box and the power lines have been disconnected from the pole and pump. Appears this crossing may have been abandoned.5/12/2015 Crossing appears in good condition. No noticeable issues to report.11/17/2014 Same as last inspection.5/12/2014 Same as last inspection.11/4/2013 Same as last inspection.5/15/2013 Same as last inspection. FIELD_STRUCT_DESC: 12-inch steel irrigation pipe crosses over canal above crown elevation. Chain link enclosure on the landside (LS) with pump, power line, and shutoff valve. 24-inch concrete standpipe on unprotected side of canal. [Additional Reference(s): DWR Levee Log, Revised 1990] FS Date: 4/12/2017 10:54:51 AM

Pump, meter, power pole, slide gate, and chainlink fence on LS with 24-inch concrete standpipe on unprotected side of canal.

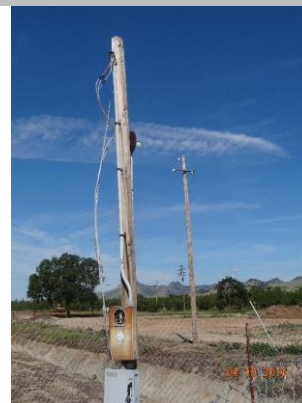
Photo 2 of 2 : UCIP\_FA\_2018\_51523\_74963.jpg

LM Start	<b>0.89</b>	Rating **	M	Issue No.	<b>26 (cont)</b>
LM End	<b>0.89</b>	Issue Type +	En	Location *

Meter removed from box and disconnected power lines

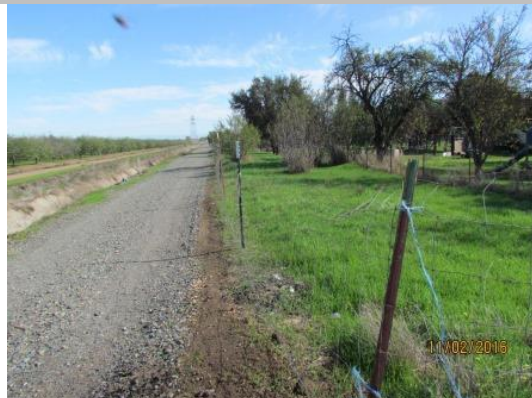
Photo 1 of 1 : FA\_2018\_ST0020\_213\_16\_20180905\_00009.jpg

View of an unauthorized fence by a landowner.

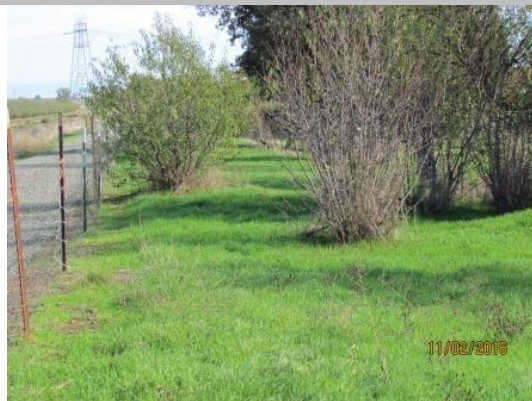
Photo 1 of 1 : FA\_2018\_ST0020\_213\_17\_20180905\_00010.jpg

LM Start	0.94	Rating **	M	Issue No.	17
LM End	0.98	Issue Type +	En	Location *	LS
Category	Earthen Levee			GPS Latitude/Longitude	
				Start	End
Item	Encroachments			39.171333 °	39.171333 °
				-121.742577 °	-121.741827 °
DWR ID	DWR_ST0020_01_f_2016_17				
Comment Code					
CR : Crops					
Inspector Comment					
Ask the landowner to remove the nut trees.

View of the nut trees planted by a landowner.

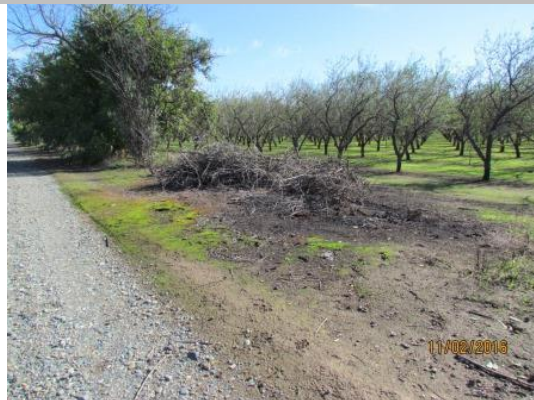
Photo 1 of 1 : FA\_2018\_ST0020\_213\_19\_20180905\_00012.jpg

View of the prunings along the landside toe.

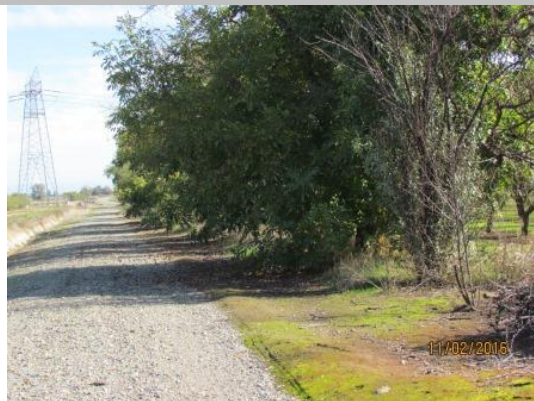
Photo 1 of 1 : FA\_2018\_ST0020\_213\_18\_20180905\_00011.jpg

LM Start	1.11	Rating **	M	Issue No.	18
LM End	1.28	Issue Type +	Ma	Location *	LS
Category	Earthen Levee			GPS Latitude/Longitude	
				Start	End
Item	Trim / Thin Trees			39.171283 °	39.171243 °
				-121.739315 °	-121.736312 °
DWR ID	DWR_ST0020_01_f_2016_18				
Comment Code					
T1 : Trim trees to at least five feet above ground level.					
Inspector Comment

View of the trees blocking visibility.

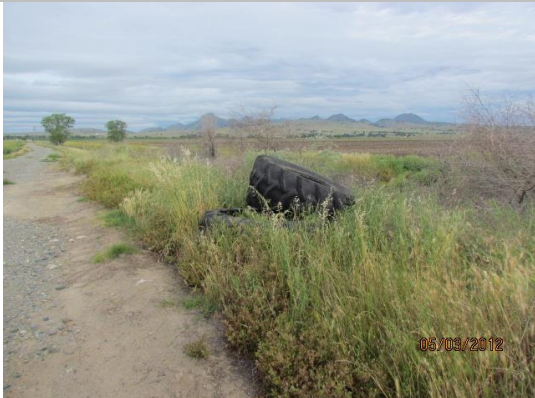
Photo 1 of 1 : FA\_2018\_ST0020\_214\_12\_20180905\_00007.jpg

View of the tires along the WS toe.

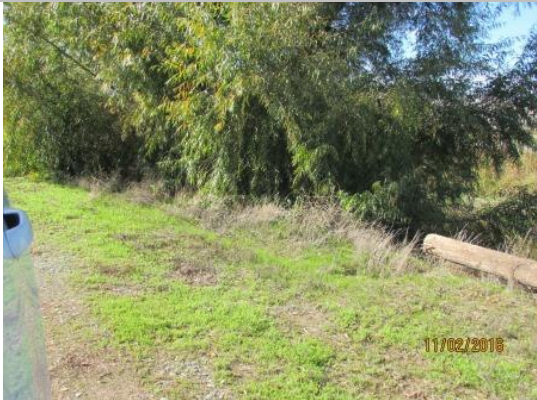
Photo 1 of 1 : FA\_2018\_ST0020\_214\_31\_20180905\_00013.jpg

View of the overgrown trees blocking visibility and access.

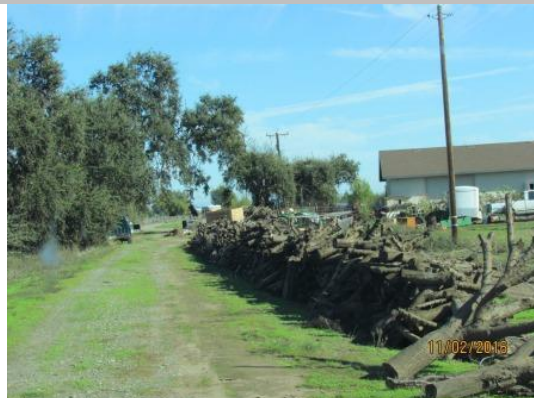
Photo 1 of 1 : FA\_2018\_ST0020\_214\_32\_20180905\_00014.jpg

View of the firewood along the landside toe.

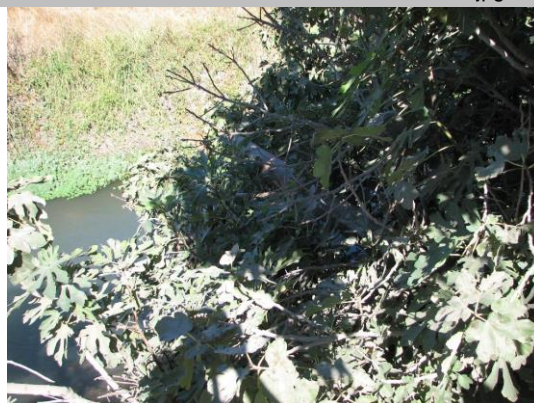
Photo 1 of 3 : UCIP\_FA\_2018\_51533\_11363.jpg

Comment Code						
Inspector Comment						
FS_ID:51533 DS_ID:19425 EP_NO: N/A Repair Type: Non-Urgent Crossing Status: Found UCIP Comments: 4/10/2017 Abandoned. (DWR Sutter Yard-AFreitag)10/11/2016 Abandoned crossing.(DWR Sutter Yard -afreitag)4/19/2016 Abandoned crossing.5/12/2015 Abandoned crossing.11/17/2014 Same as last inspection.5/12/2014 Same as last inspection.11/4/2013 Same as last inspection.5/15/2013 Same as last inspection.10/16/2012 Pipe and pump abandoned. Pipe should be removed or properly abandoned. FIELD_STRUCT_DESC: 8-inch galvanized iron irrigation pipe through the levee, 2 feet below the crown. 7.5 horsepower (HP) pump located in canal on the waterside (WS). [Additional Reference(s): DWR Levee Log, 1990. USACE Sacramento O&M Manual 135 (revision), May 1953, (HLM 0.39), Page 11, Location Section 12, As-Built Drawing No. 50-10-2816]. FS Date: 4/12/2017 12:04:00 PM

Pipe on LS slope.

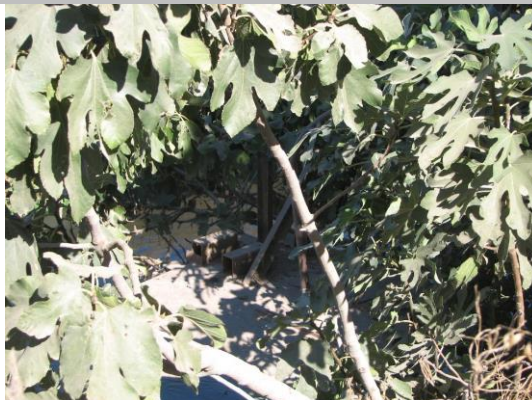
Photo 2 of 3 : UCIP\_FA\_2018\_51533\_11362.jpg

Pump platform on LS slope.

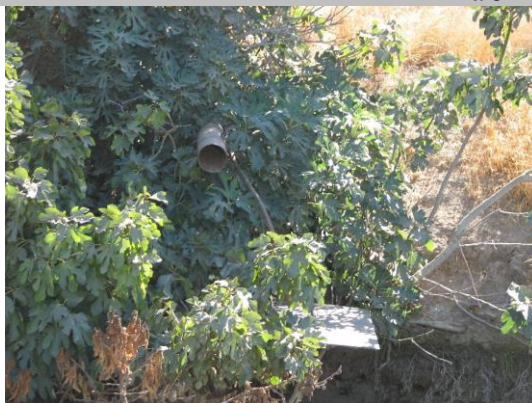
Photo 3 of 3 : UCIP\_FA\_2018\_51533\_11361.jpg

View of pipe from unprotected side of levee.

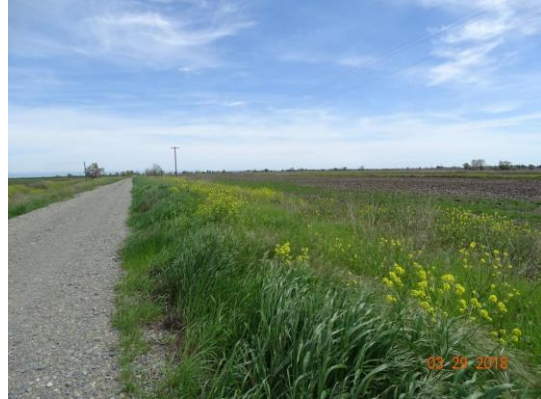
Photo 2 of 2 : FA\_2018\_ST0020\_214\_19\_20180905\_00008.jpg

View of the vegetation along the landside slope.

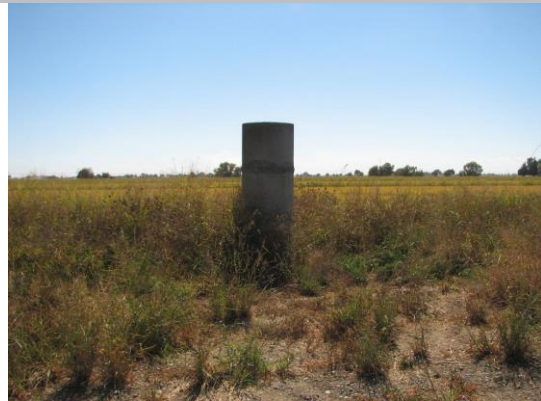
Photo 1 of 3 : UCIP\_FA\_2018\_51534\_11391.jpg

Comment Code					
Inspector Comment					
FS_ID:51534 DS_ID:19426 EP_NO: N/A Repair Type: Non-Urgent Crossing Status: Found UCIP Comments: 4/10/2017 Abandoned. (DWR Sutter Yard-AFreitag)10/11/2016 Abandoned crossing.(DWR Sutter Yard - a/freitag)4/19/2016 Abandoned crossing.5/12/2015 Abandoned crossing. Needs to be properly abandoned.11/17/2014 Same as last inspection.5/12/2014 Same as last inspection.11/4/2013 Same as last inspection.5/15/2013 Same as last inspection.10/16/2012 Pumping plant abandoned. Pipe abandoned and only visible at bottom of concrete standpipe. Pipe needs to be abandoned properly. FIELD_STRUCT_DESC: 12-inch galvanized iron irrigation pipe through the levee, 6 feet below the crown. 10 horsepower (HP) pump in the canal, and power pole located on the waterside (WS). 36-inch concrete standpipe located on the landside (LS) shoulder. [Additional Reference(s): DWR Levee Log, 1990. USACE Sacramento O&M Manual 135, May 1953, (HLM 0.74), Page 11, Location Section 19, As-Built Drawing No. 50-10-2816]. FS Date: 4/12/2017 12:04:36 PM

Concrete standpipe on LS shoulder.

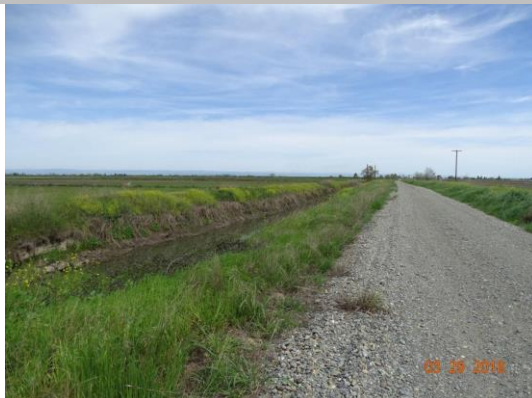
Photo 1 of 2 : FA\_2018\_ST0020\_214\_20\_20180905\_00010.jpg

View of the native vegetation on the waterside slope.

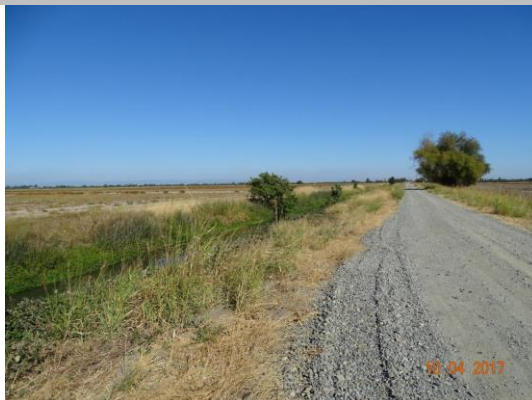
Photo 2 of 2 : FA\_2018\_ST0020\_214\_20\_20180905\_00011.jpg

LM Start	<b>0.95</b>	Rating **	M	Issue No.	<b>20 (cont)</b>
LM End	<b>1.32</b>	Issue Type +	Ma	Location *	WS

View of the native vegetation on the waterside slope.

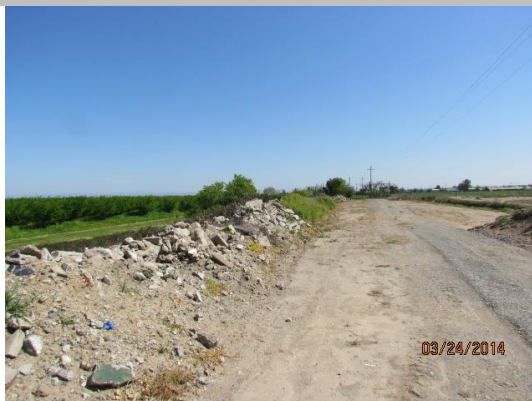
Photo 1 of 2 : FA\_2018\_ST0020\_214\_3\_20180905\_00001.jpg

LM Start	1.43	Rating **	M	Issue No.	3
LM End	1.52	Issue Type +	En	Location *	LS
Category	Earthen Levee			GPS Latitude/Longitude	
				Start	End
Item	Encroachments			39.170782 °	39.170865 °
				-121.700167 °	-121.698165 °
DWR ID	DWR_ST0020_02_f_2018_3				
Comment Code					
DE : Debris					
Inspector Comment					
Remove the broken concrete.

View of the piles of broken concrete.

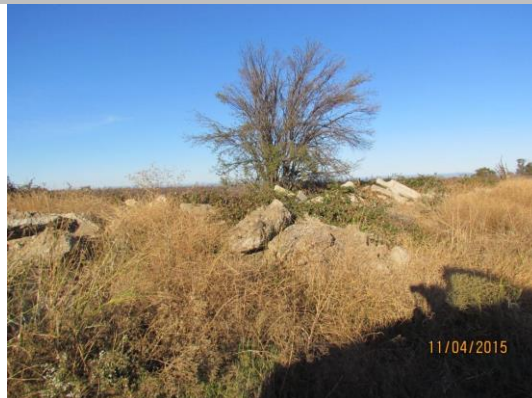
Photo 2 of 2 : FA\_2018\_ST0020\_214\_3\_20180905\_00002.jpg

LM Start	1.43	Rating **	M	Issue No.	3 (cont)	
LM End	1.52	Issue Type +	En	Location *	LS	
Category	Earthen Levee			GPS Latitude/Longitude		
				Start		End
Item	Encroachments			39.170782 °		39.170865 °
				-121.700167 °		-121.698165 °
DWR ID	DWR_ST0020_02_f_2018_3					
Comment Code						
DE : Debris						
Inspector Comment						
Remove the broken concrete.

View of the pile of broken concrete.

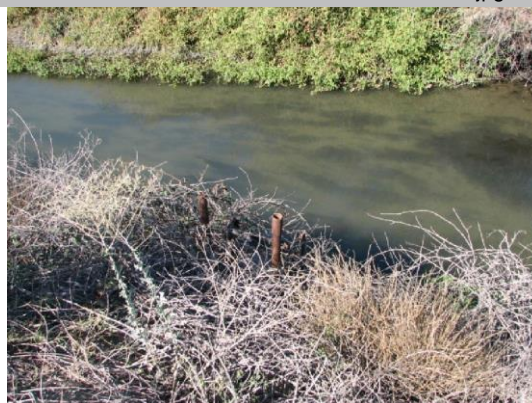
Photo 1 of 3 : UCIP\_FA\_2018\_51539\_11406.jpg

Comment Code						
Inspector Comment						
FS_ID:51539 DS_ID:19423 EP_NO: N/A Repair Type: Non-Urgent Crossing Status: Found UCIP Comments: 4/10/2017 LS inlet is buried, WS pipe outlet is overgrown with the flapgate being the only thing that is barely visible. (DWR Sutter Yard- AFreitag)10/11/2016 LS inlet is buried and WS flapgate is overgrown with blackberries.(DWR Sutter Yard - afreitag)4/19/2016 WS flapgate is completely overgrown with blackberries. 5/12/2015 LS inlet still buried with soil and blackberries on WS have blocked the flap gate.LS intake is filled and blocked with soil.11/17/2014 Ws outlet of pipe is overgrown and blocked from opening by blackberries. LS inlet still appears to be buried/blocked by soil.5/12/2014 Same as last inspection.11/4/2013 Same as last inspection.5/15/2013 Same as last inspection. FIELD_STRUCT_DESC: 16-inch corrugated metal drainage pipe through the levee, 5 feet below the crown. Flap gate located on the waterside (WS) end. Landside (LS) inlet filled and blocked with soil in 2012. [Additional Reference(s): DWR Levee Log, Revised 1990]. FS Date: 4/12/2017 12:07:34 PM

Pipe with flapgate at outlet on WS slope.

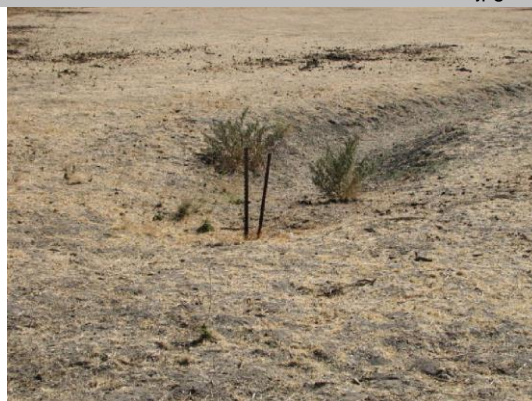
Photo 2 of 3 : UCIP\_FA\_2018\_51539\_11405.jpg

Burried inlet 30 feet from LS shoulder.

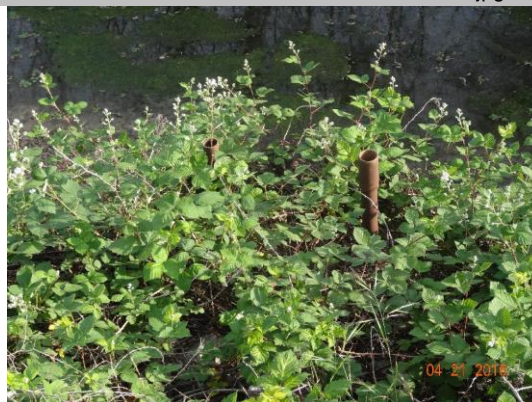
Photo 3 of 3 : UCIP\_FA\_2018\_51539\_74966.jpg

WS flapgate overgrown by blackberries

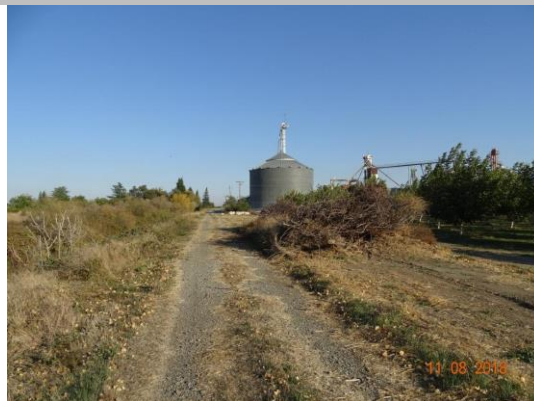
Photo 1 of 1 : FA\_2018\_ST0020\_214\_21\_20181113\_00045.jpg

View of the prunings along the landside berm.

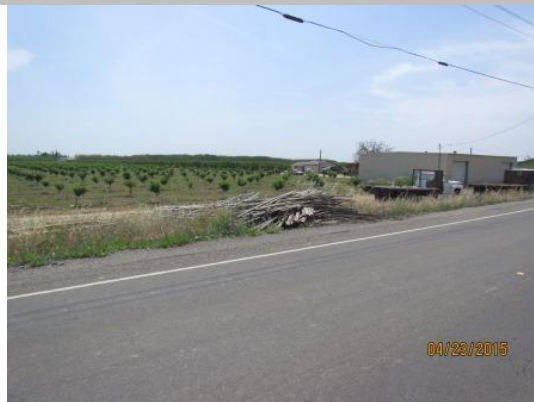
Photo 1 of 1 : FA\_2018\_ST0020\_214\_10\_20180905\_00006.jpg

View of the material, garbage, and equipment along the landside toe
